# Manhole Inspection Summary

Manhole # S07AA2019MH

**Location** Address: **2631 GLEN AVE**

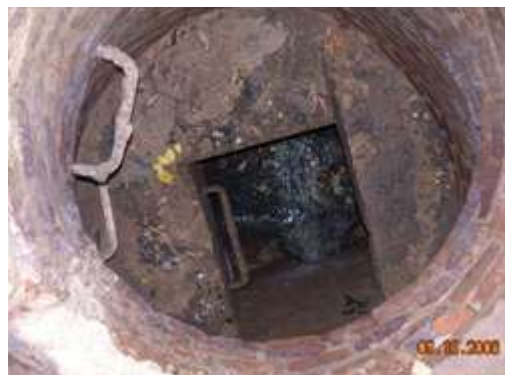
Top View

Adjustment and Corbel infiltration.  
Corroded steps. Channel debris.

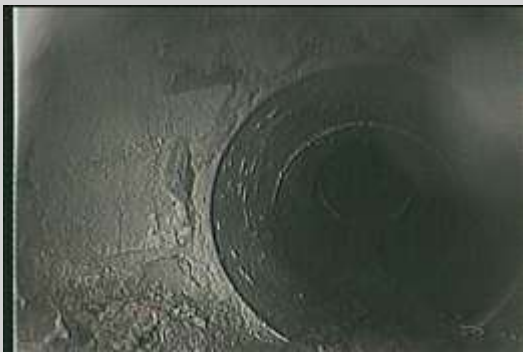
### 12 in. Circular Gravity Sewer Pipe Out @ 12 O'Clock

Infiltration: **Evidence** Pipe Seal Cond: **Cracked**

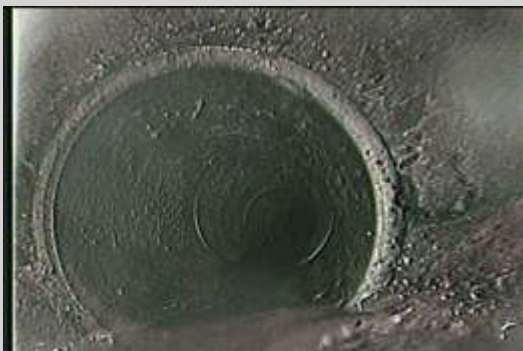
### 10 in. Circular Gravity Sewer Pipe In @ 6 O'Clock

Infiltration: **Evidence** Pipe Seal Cond: **Unknown**

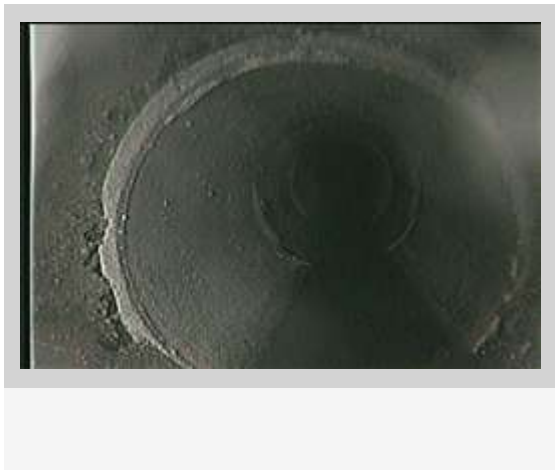
12 in. Circular Gravity Sewer  
Pipe In @ 9 O'Clock

Infiltration: **Evidence** Pipe Seal Cond: **Unknown**
